Incremental SRA (ISRA)

Mid-Atlantic RMC

We Fix Ships!

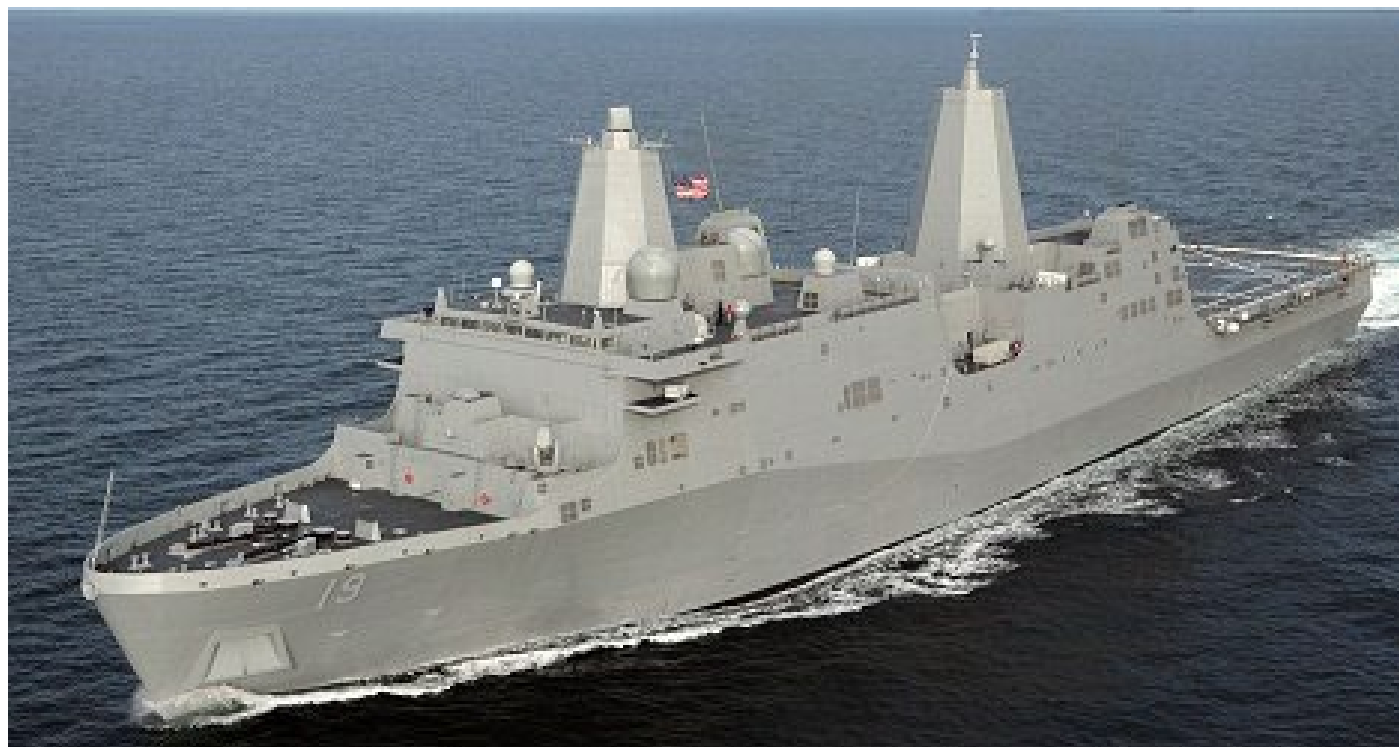
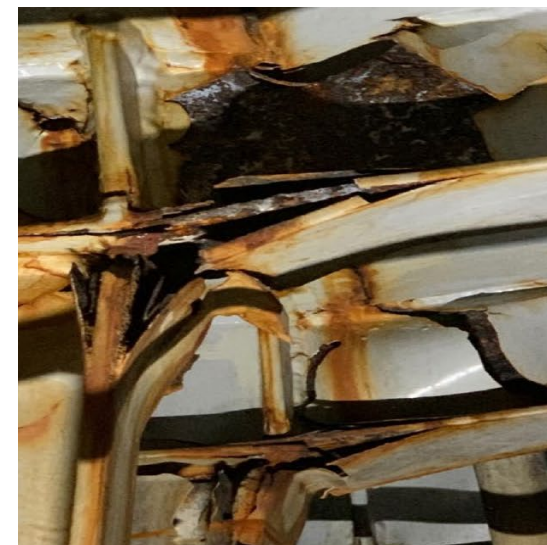
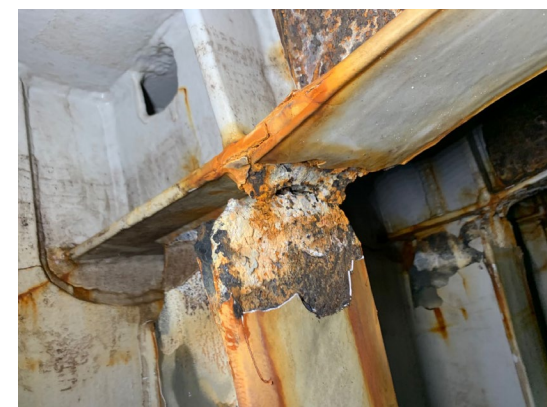
USS Mesa Verde (LPD 19)

Ballast Tank Repair

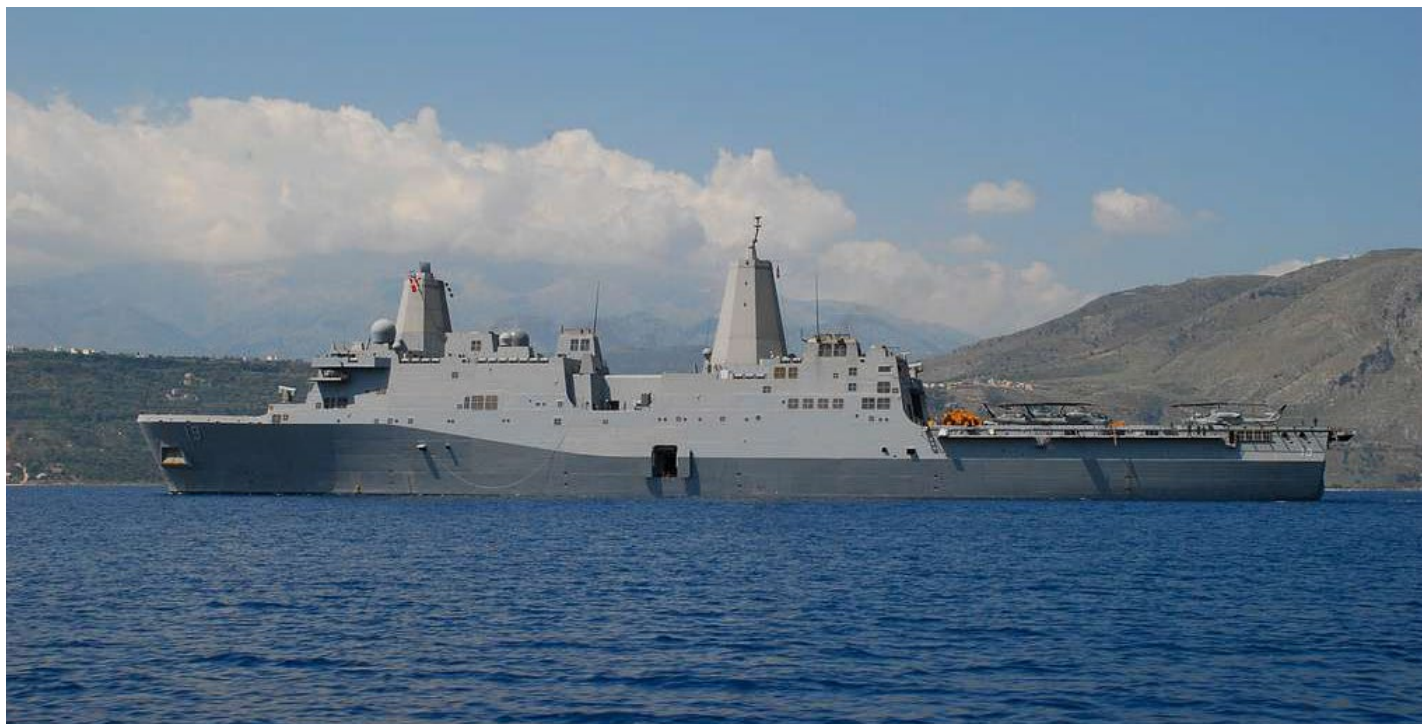
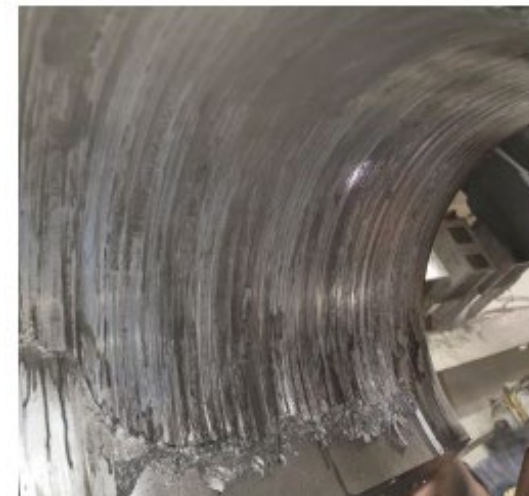
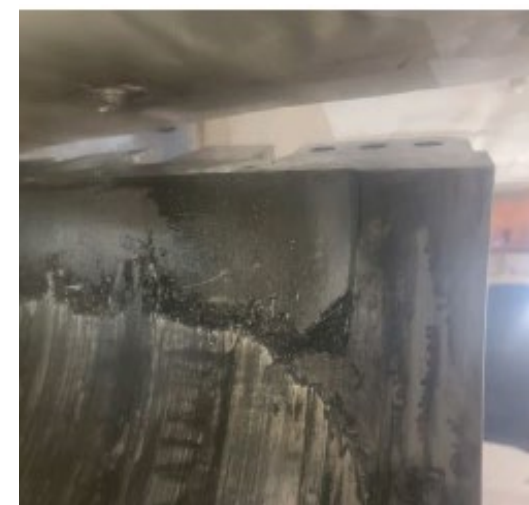
USS Mesa Verde (LPD 19)

Line Shaft Bearing Repairs

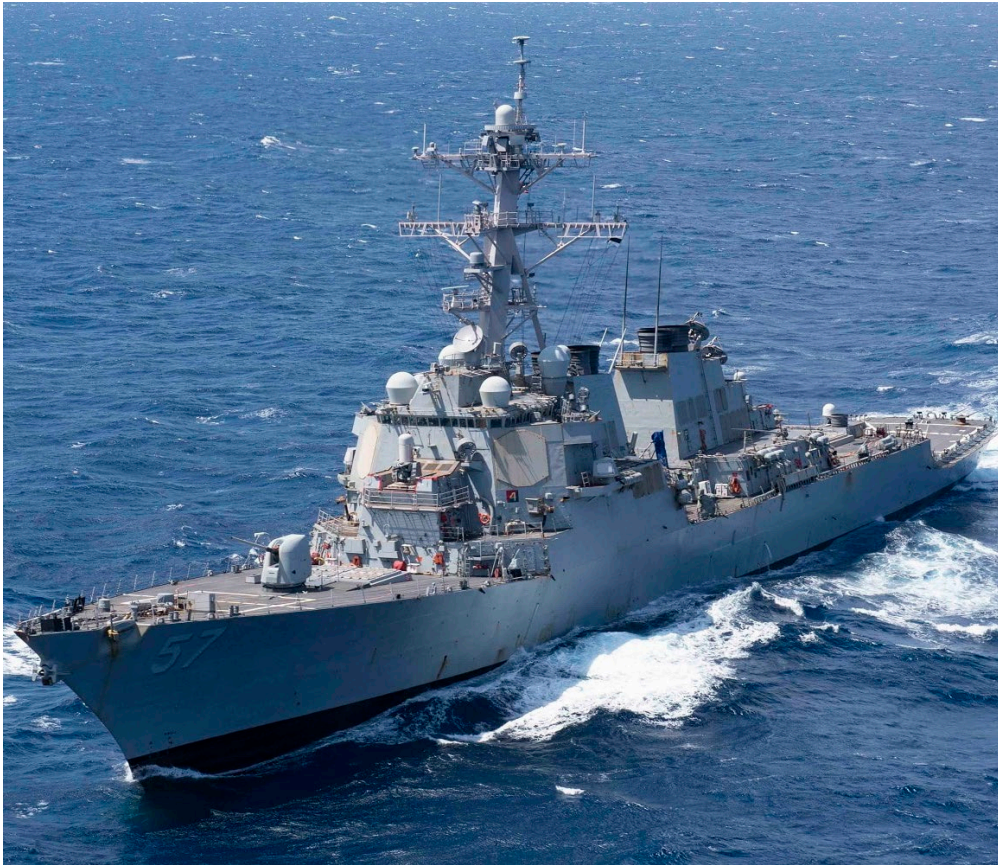
USS Mitscher (DDG 57)

Tail Shaft Repairs

12 x external
bolt holes

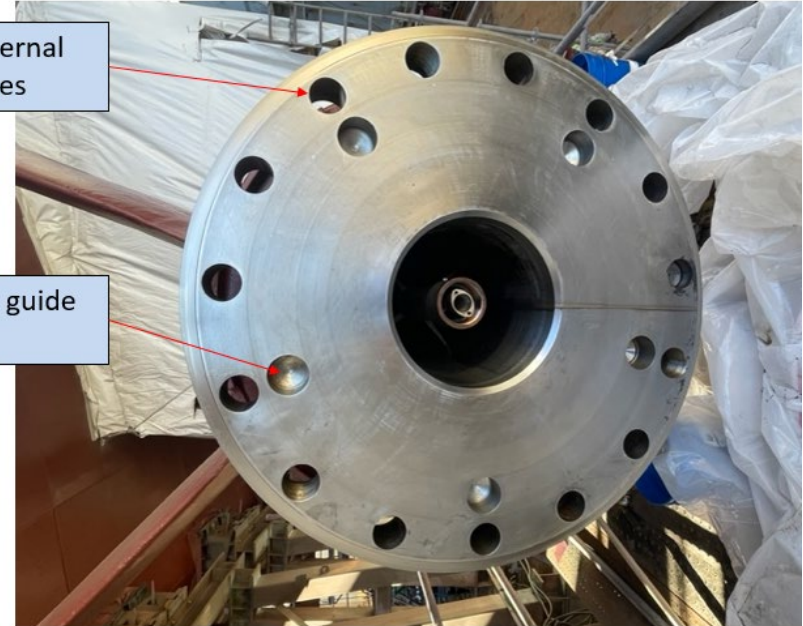
5 x internal guide
pin holes

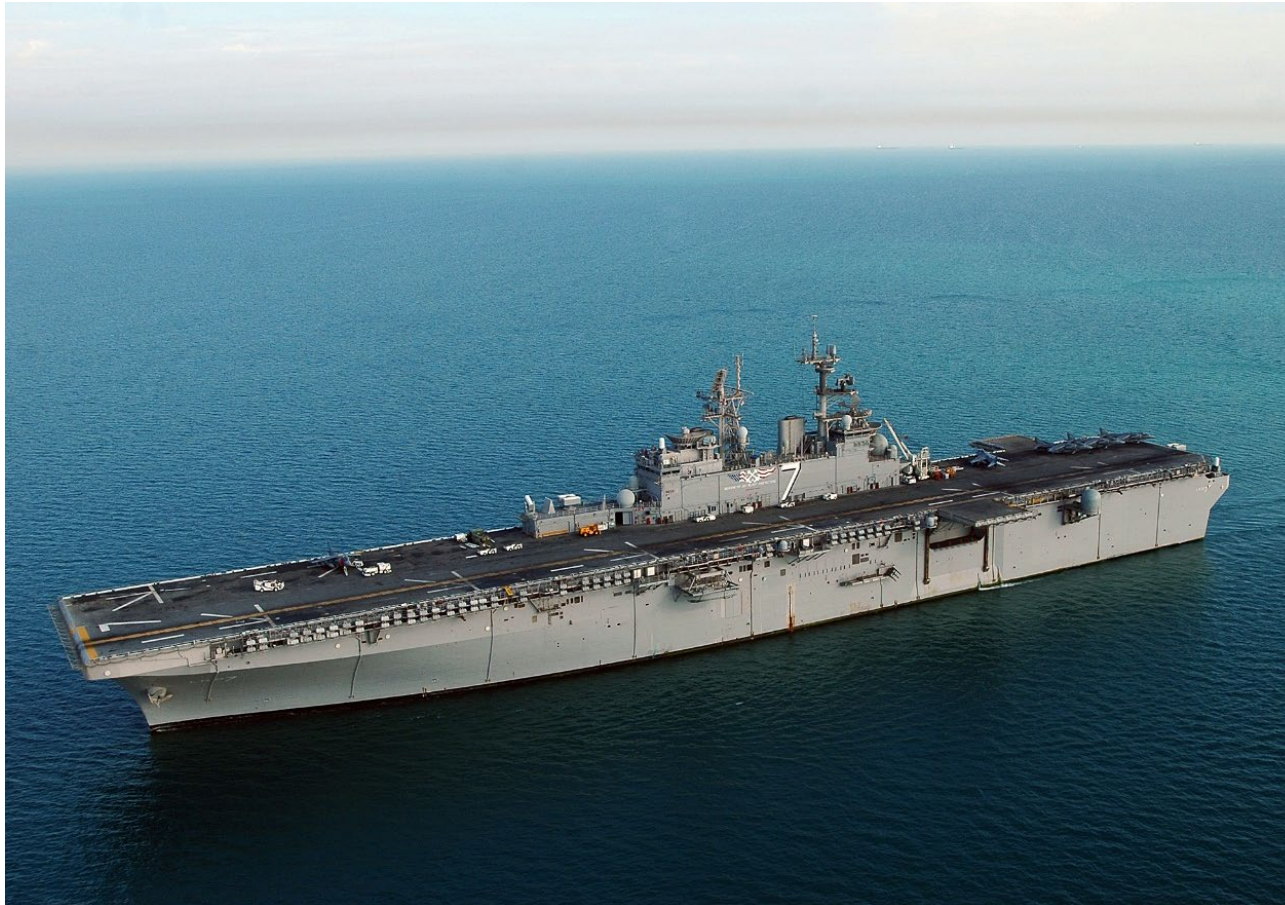
USS Iwo Jima (LHD 7)

In-Water Rudder Installation

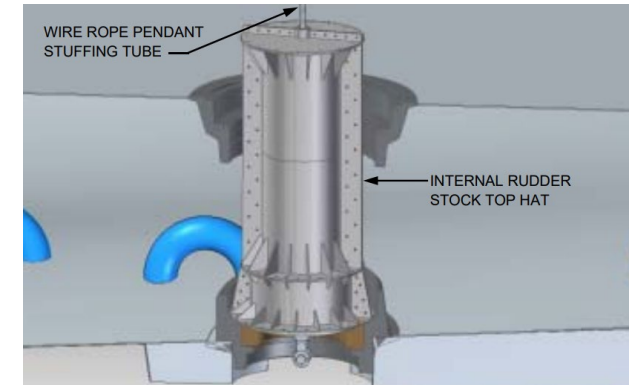
Internal cofferdam assembly

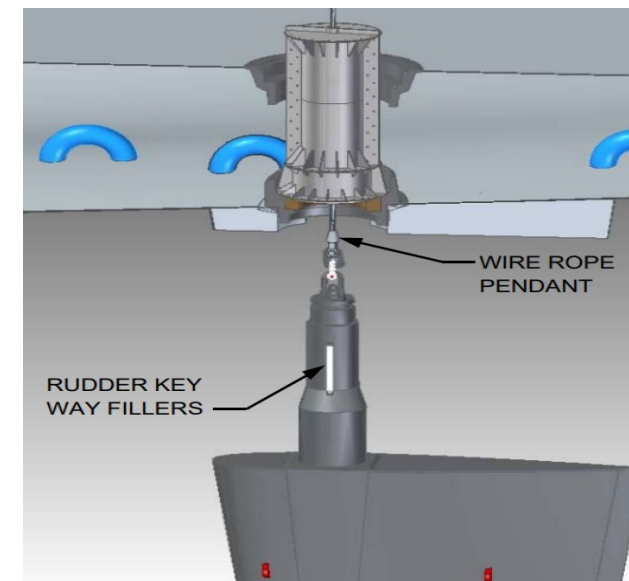
Rudder/stock rigged/raised under hull
